# Final report on potential breaches of biosecurity at the Pirbright site 2007

# Statement of key conclusions and recommendations

# Background

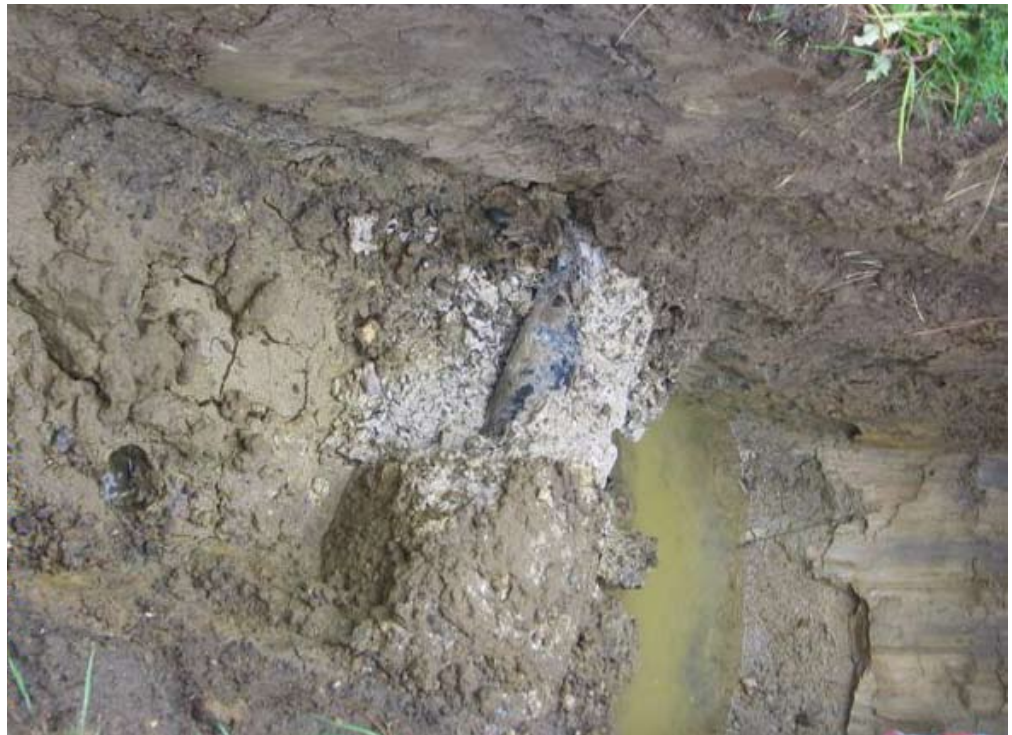
**Figure 5** Main effluent pipe from Merial sump, exposed by IAH-appointed contractors on 25–26 July 2007

219 Following a basic inspection, this work did not appear to have damaged the pipe. However, a full examination was not possible as the pipe is encased in concrete and remains buried. The CCTV drainage survey did not cover this stretch of pipe as it contained liquid effluent, preventing access to the camera equipment.

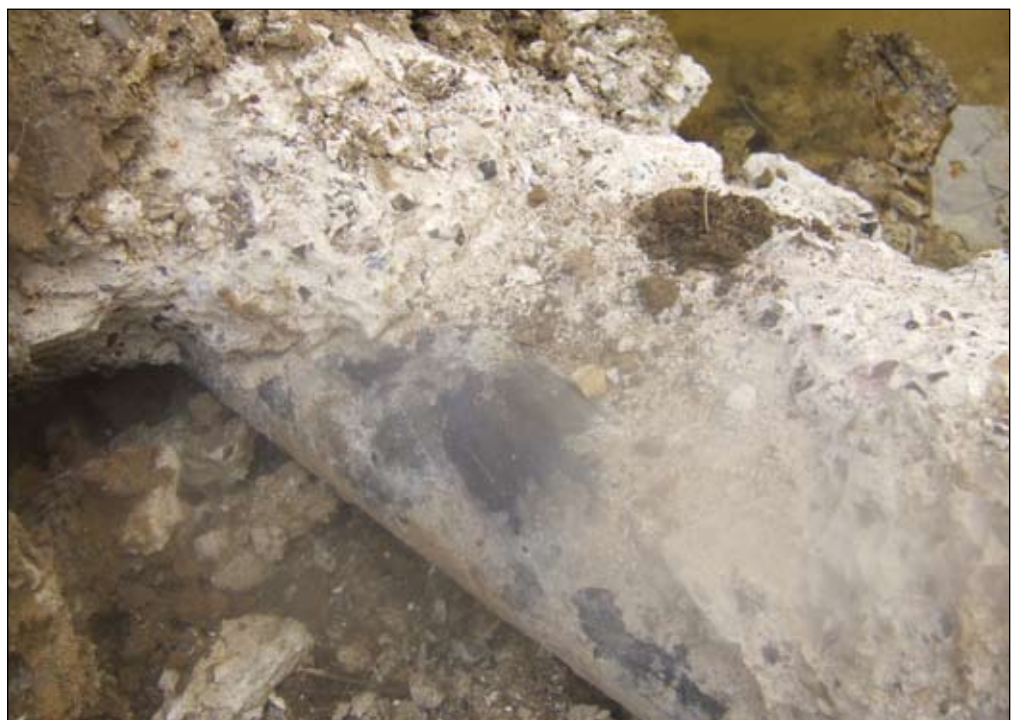
**Figure 13** Cast iron discharge main from Merial sump

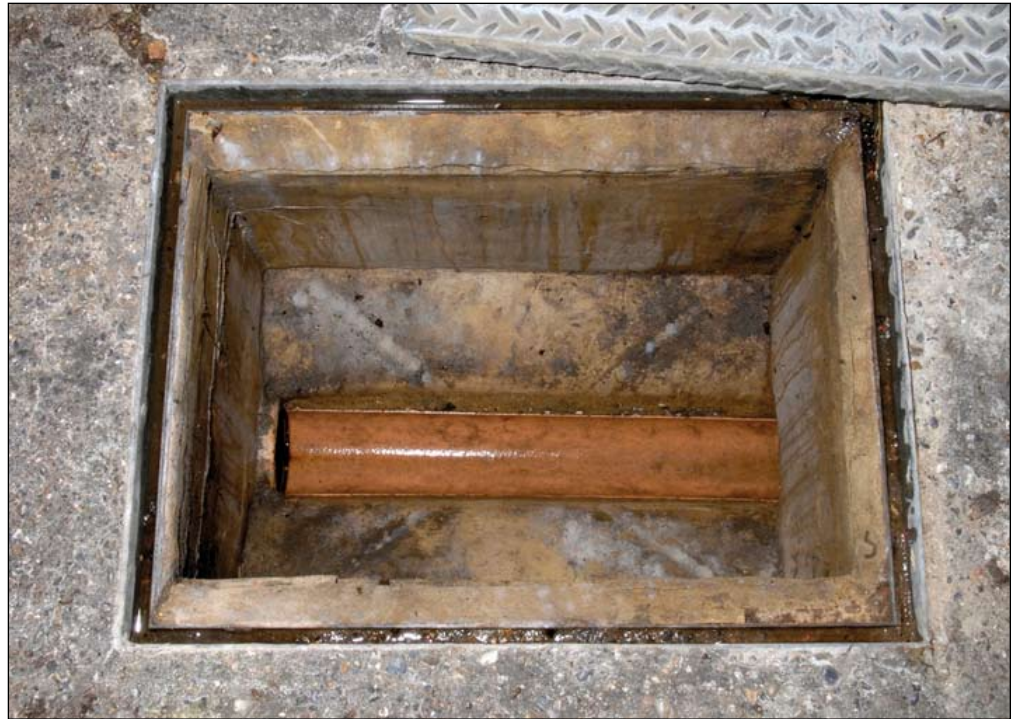
**Figure 14** Manhole FM1

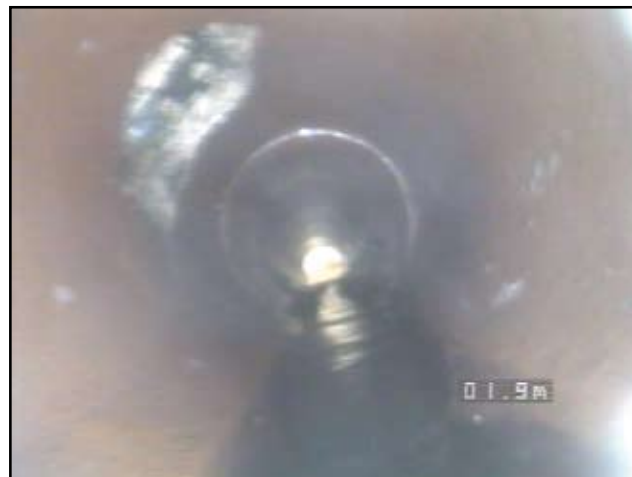
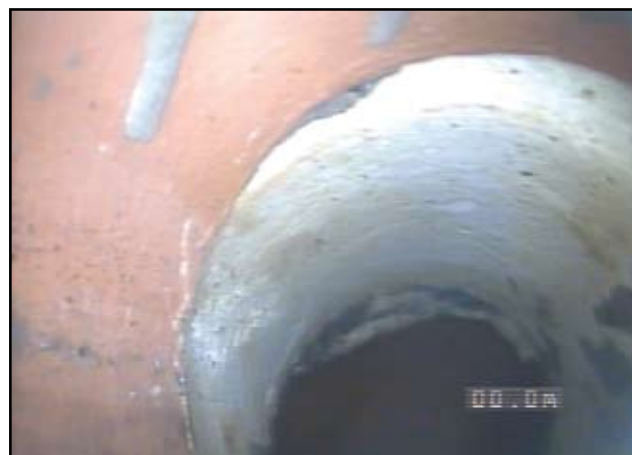
**Figure 15** Connection point of discharge line from FM1 to main IAH northern line  
(a) view from main line (b) view from FM1

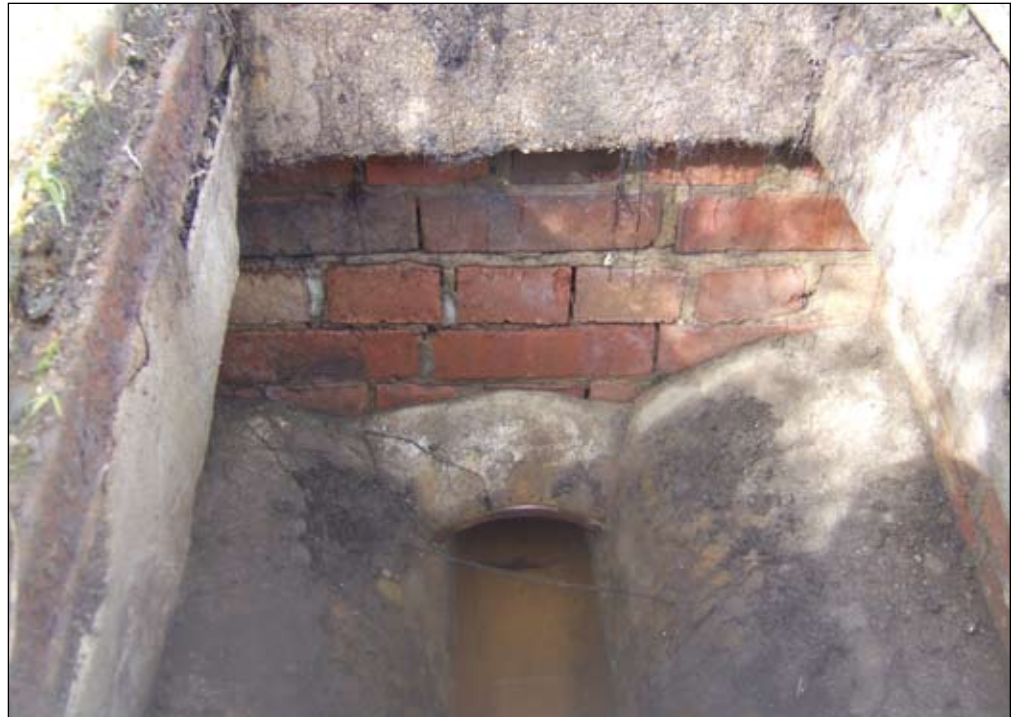
**Figure 16** Manhole FM2 showing damaged mortar joints

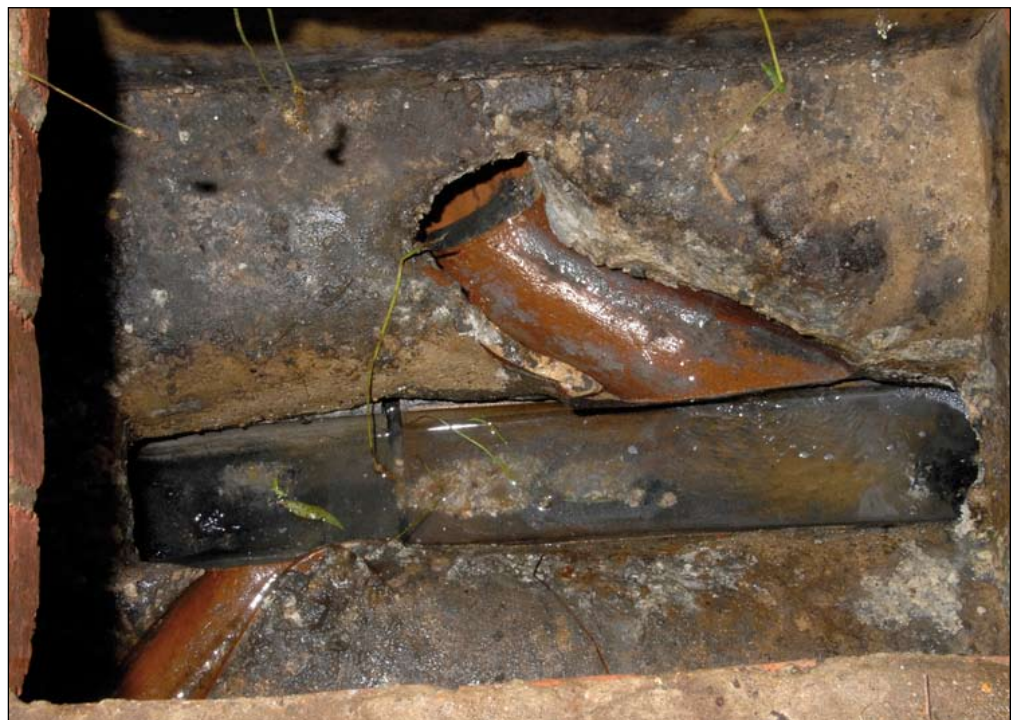
**Figure 17** Manhole FN4 showing damage around invert opposite Merial feed

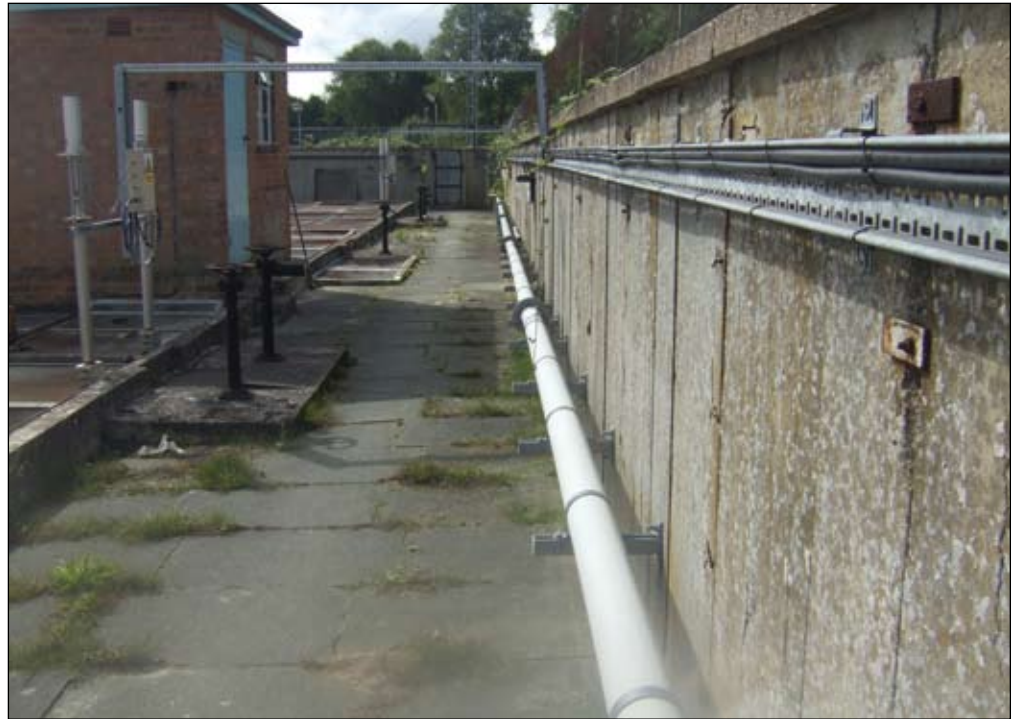
**Figure 18** Discharge line from effluent treatment plant to Braithwaite tanks

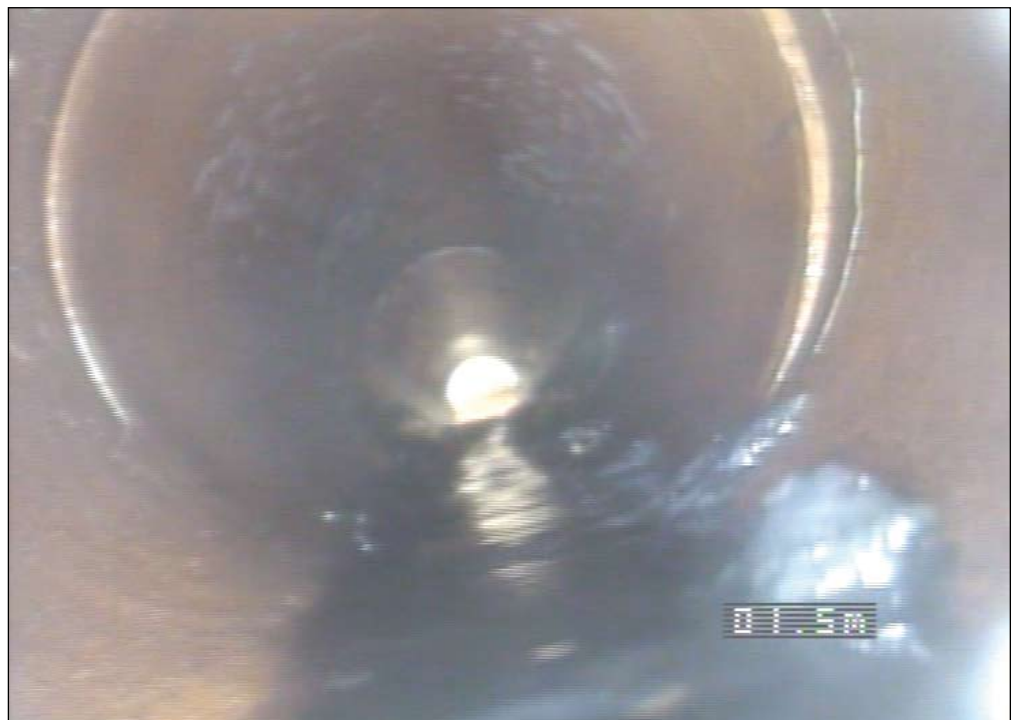
**Figure 19** Typical pipe misalignment at a joint and crack damage

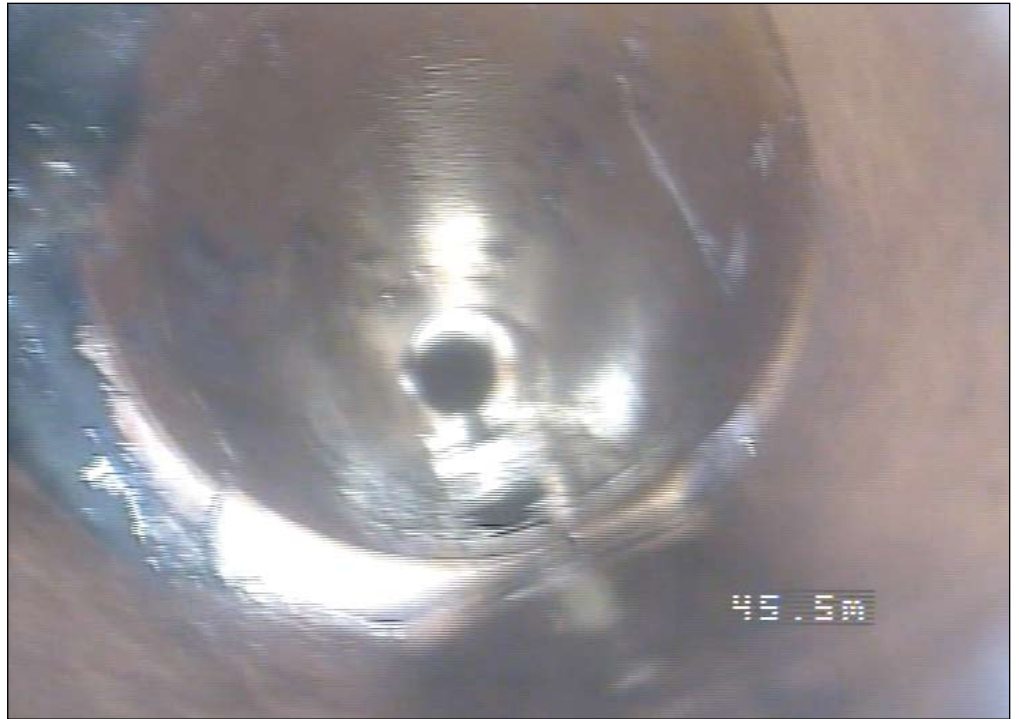
**Figure 20** Root penetration into pipe-displacement of joint and cracking of rear pipe also visible

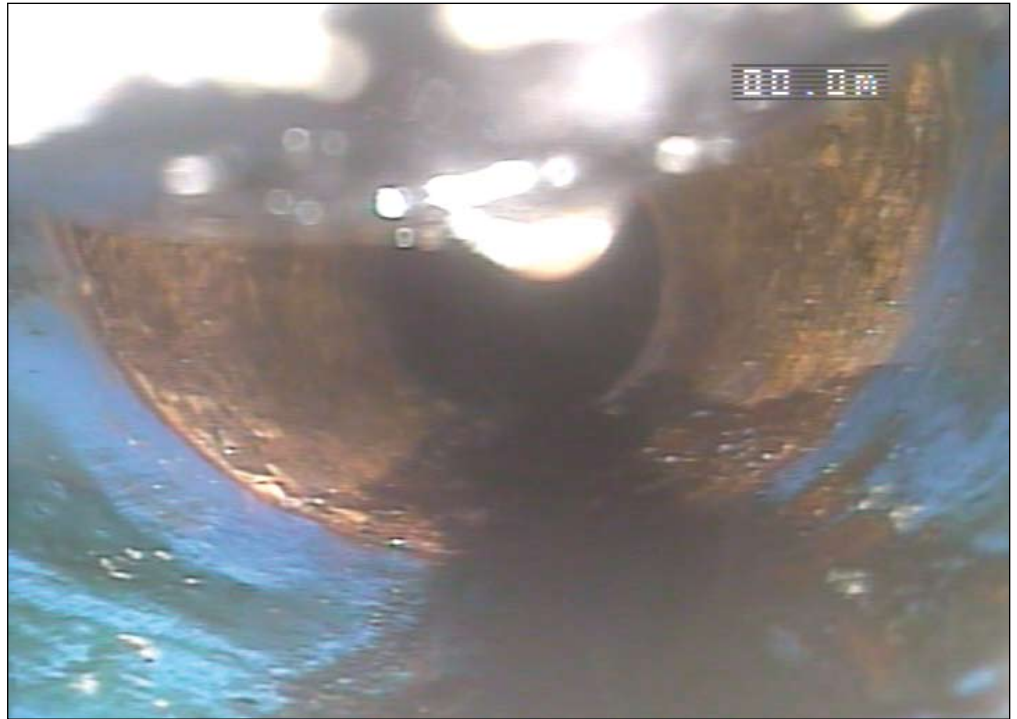
**Figure 22** Heavy corrosion on the cast iron section adjacent to the ETP valve
