Tower Blueprints

Surviving Evidence of the World Trade Center Attack

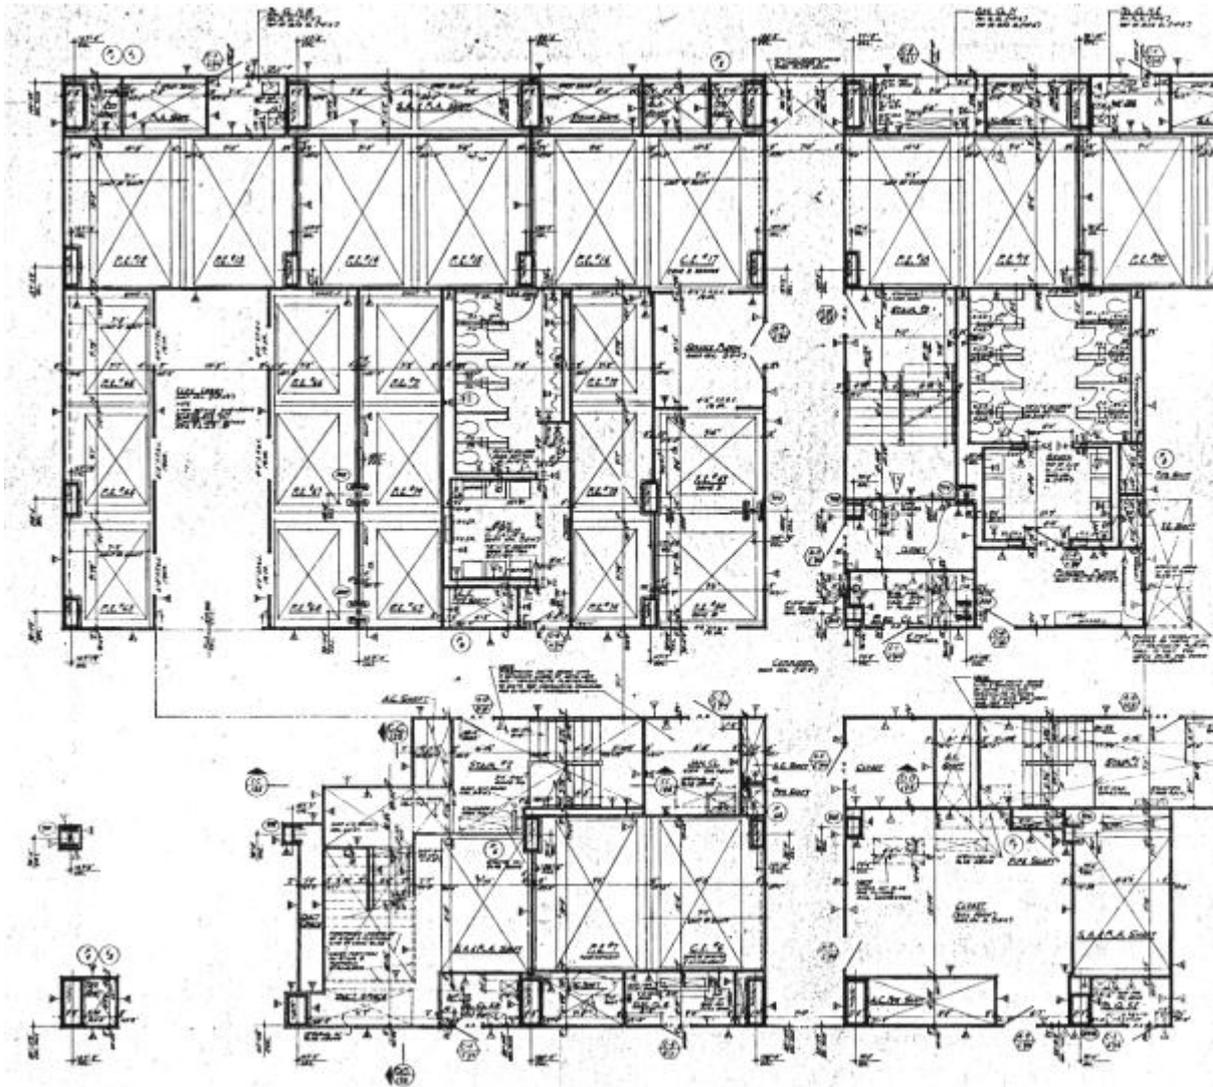
This 66th floor core plan included in the detailed architectural drawings shows that most of the core columns retained their full outside dimensions well above the midpoints of the Towers. Of the sixteen columns bounding the long faces of the core, thirteen have outside dimensions of approximately 54 by 22 inches in this 66th floor section.

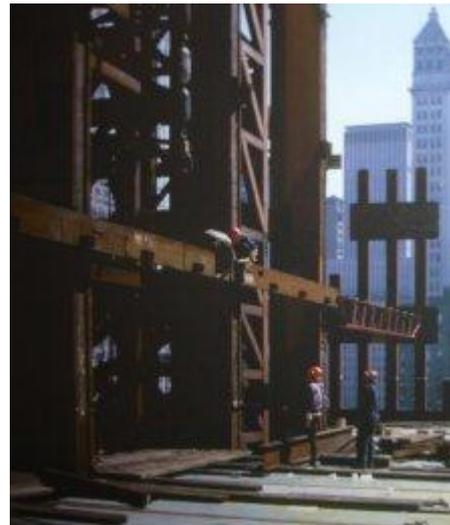
Portion of photograph in the collection of the Skyscraper Museum

Based on [construction photographs](#) exhibited in the Skyscraper Museum and [illustrations from the *Engineering News Record*](#), 9-11 Research had established by mid-2005 that, low in the Towers, the sixteen core columns that bounded the long faces of the buildings' [cores](#) had dimensions of 54 by 22 inches. The detailed drawings show that these columns maintained these dimensions through about the 66th floor.

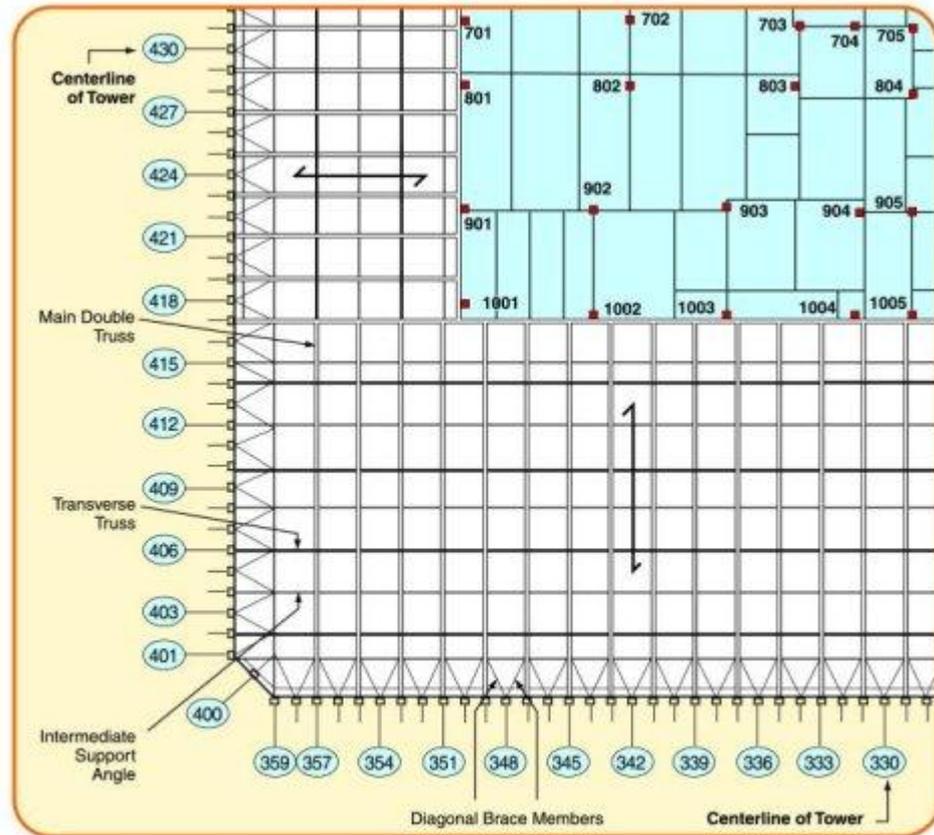
Figure 2-2 Representative structural framing plan, upper floors.

Figure 2-2 of FEMA's *Building Performance Study*, labeled "Representative structural framing plan, upper floors", is one of five illustrations in the report that depict core columns. Each of these illustrations depicts the core columns at their minimum dimensions, and none depict them at their typical dimensions.

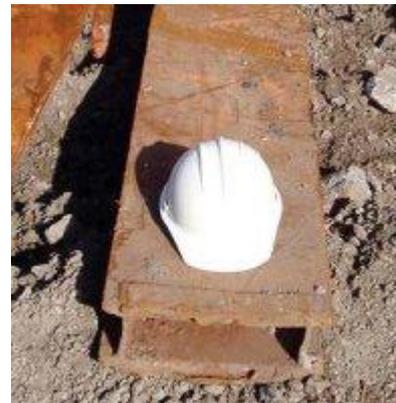
Figure D-13 from FEMA's Study, bearing the caption "WTC 1 or WTC 2 core column (C-74)", is the only photograph in the Study that shows an identified core column

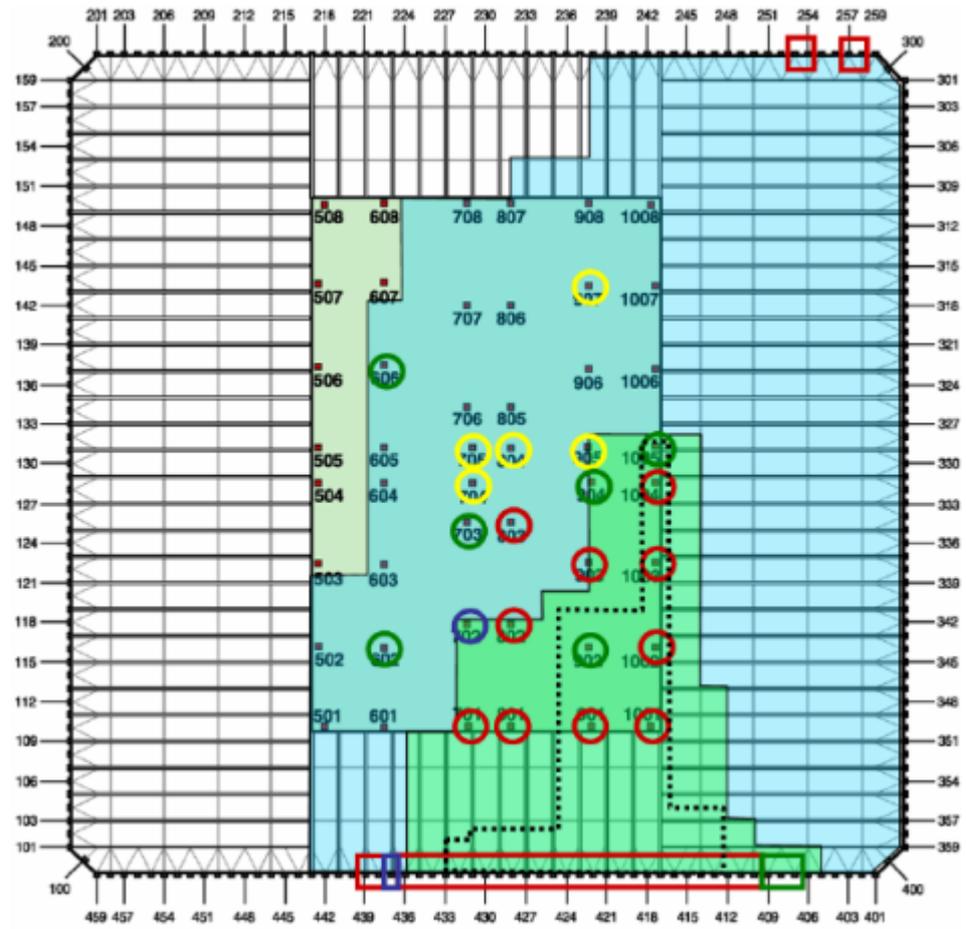
Figure 3-3 From NIST's Final Report drastically misrepresents the dimensions of the core columns on the 78th through the 83rd floors.

Illustrations in the Report depict the core columns at the North and South Tower crash zones as being the same size, when in fact the core columns were much broader around the 80th floor than around the 95th. NIST's failure to highlight this difference is especially interesting in light of its estimates of core column damage in the Towers. Those estimates show 10 of the South Tower's core columns severed, compared to only 6 of the North Tower's. How could the South Tower's core have had more damage when its impact-level columns were twice as large as the North Tower's and it sustained only a glancing rather than a head-on impact? Was NIST struggling to explain how the South Tower succumbed to "global collapse" almost twice as quickly as the North Tower despite having much smaller fires?

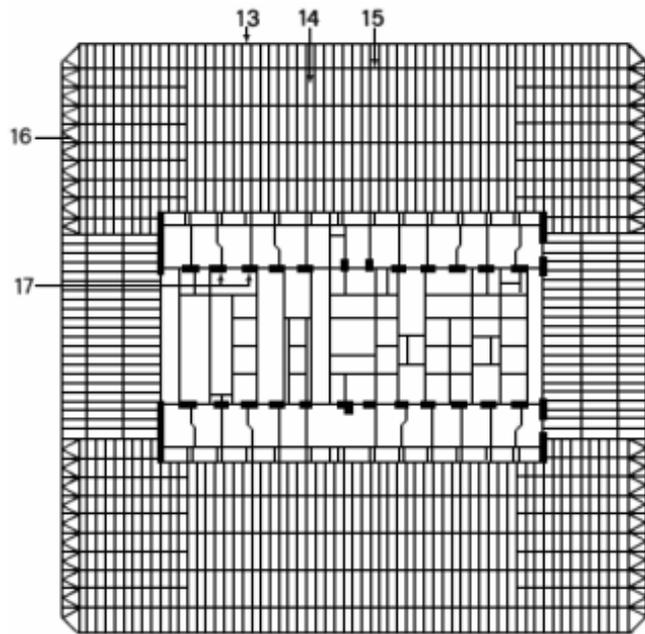
This illustration from 'Multi-Storey Buildings in Steel' shows a structural system that matches the drawings in the MASTER PLAN. [Multi-Storey Buildings in Steel](#)

Prior to the release of the detailed architectural drawings, 9-11 Research published the [MASTER PLAN](#), dated December 16, 1963. The MASTER PLAN does not show structural details such as column dimensions, and shows an arrangement of core columns that was later changed. The obsolete core column arrangement indicated in the MASTER PLAN has been reproduced in other publications such as the book 'Multi-Storey Buildings in Steel'.⁴
