SUBJECT Exploitation of Metallic Fragment from Unidentified Flying Object

EXPLOITATION OF METALLIC FRAGMENT FROM UNIDENTIFIED FLYING OBJECT

(U) FRAGMENT, METAL, RECOVERED IN THE REPUBLIC OF THE CONGO, CLAIMED BELIEVED TO BE AN UNIDENTIFIED FLYING OBJECT (COUNTRY UNIDENTIFIED) (U

MCN-25100

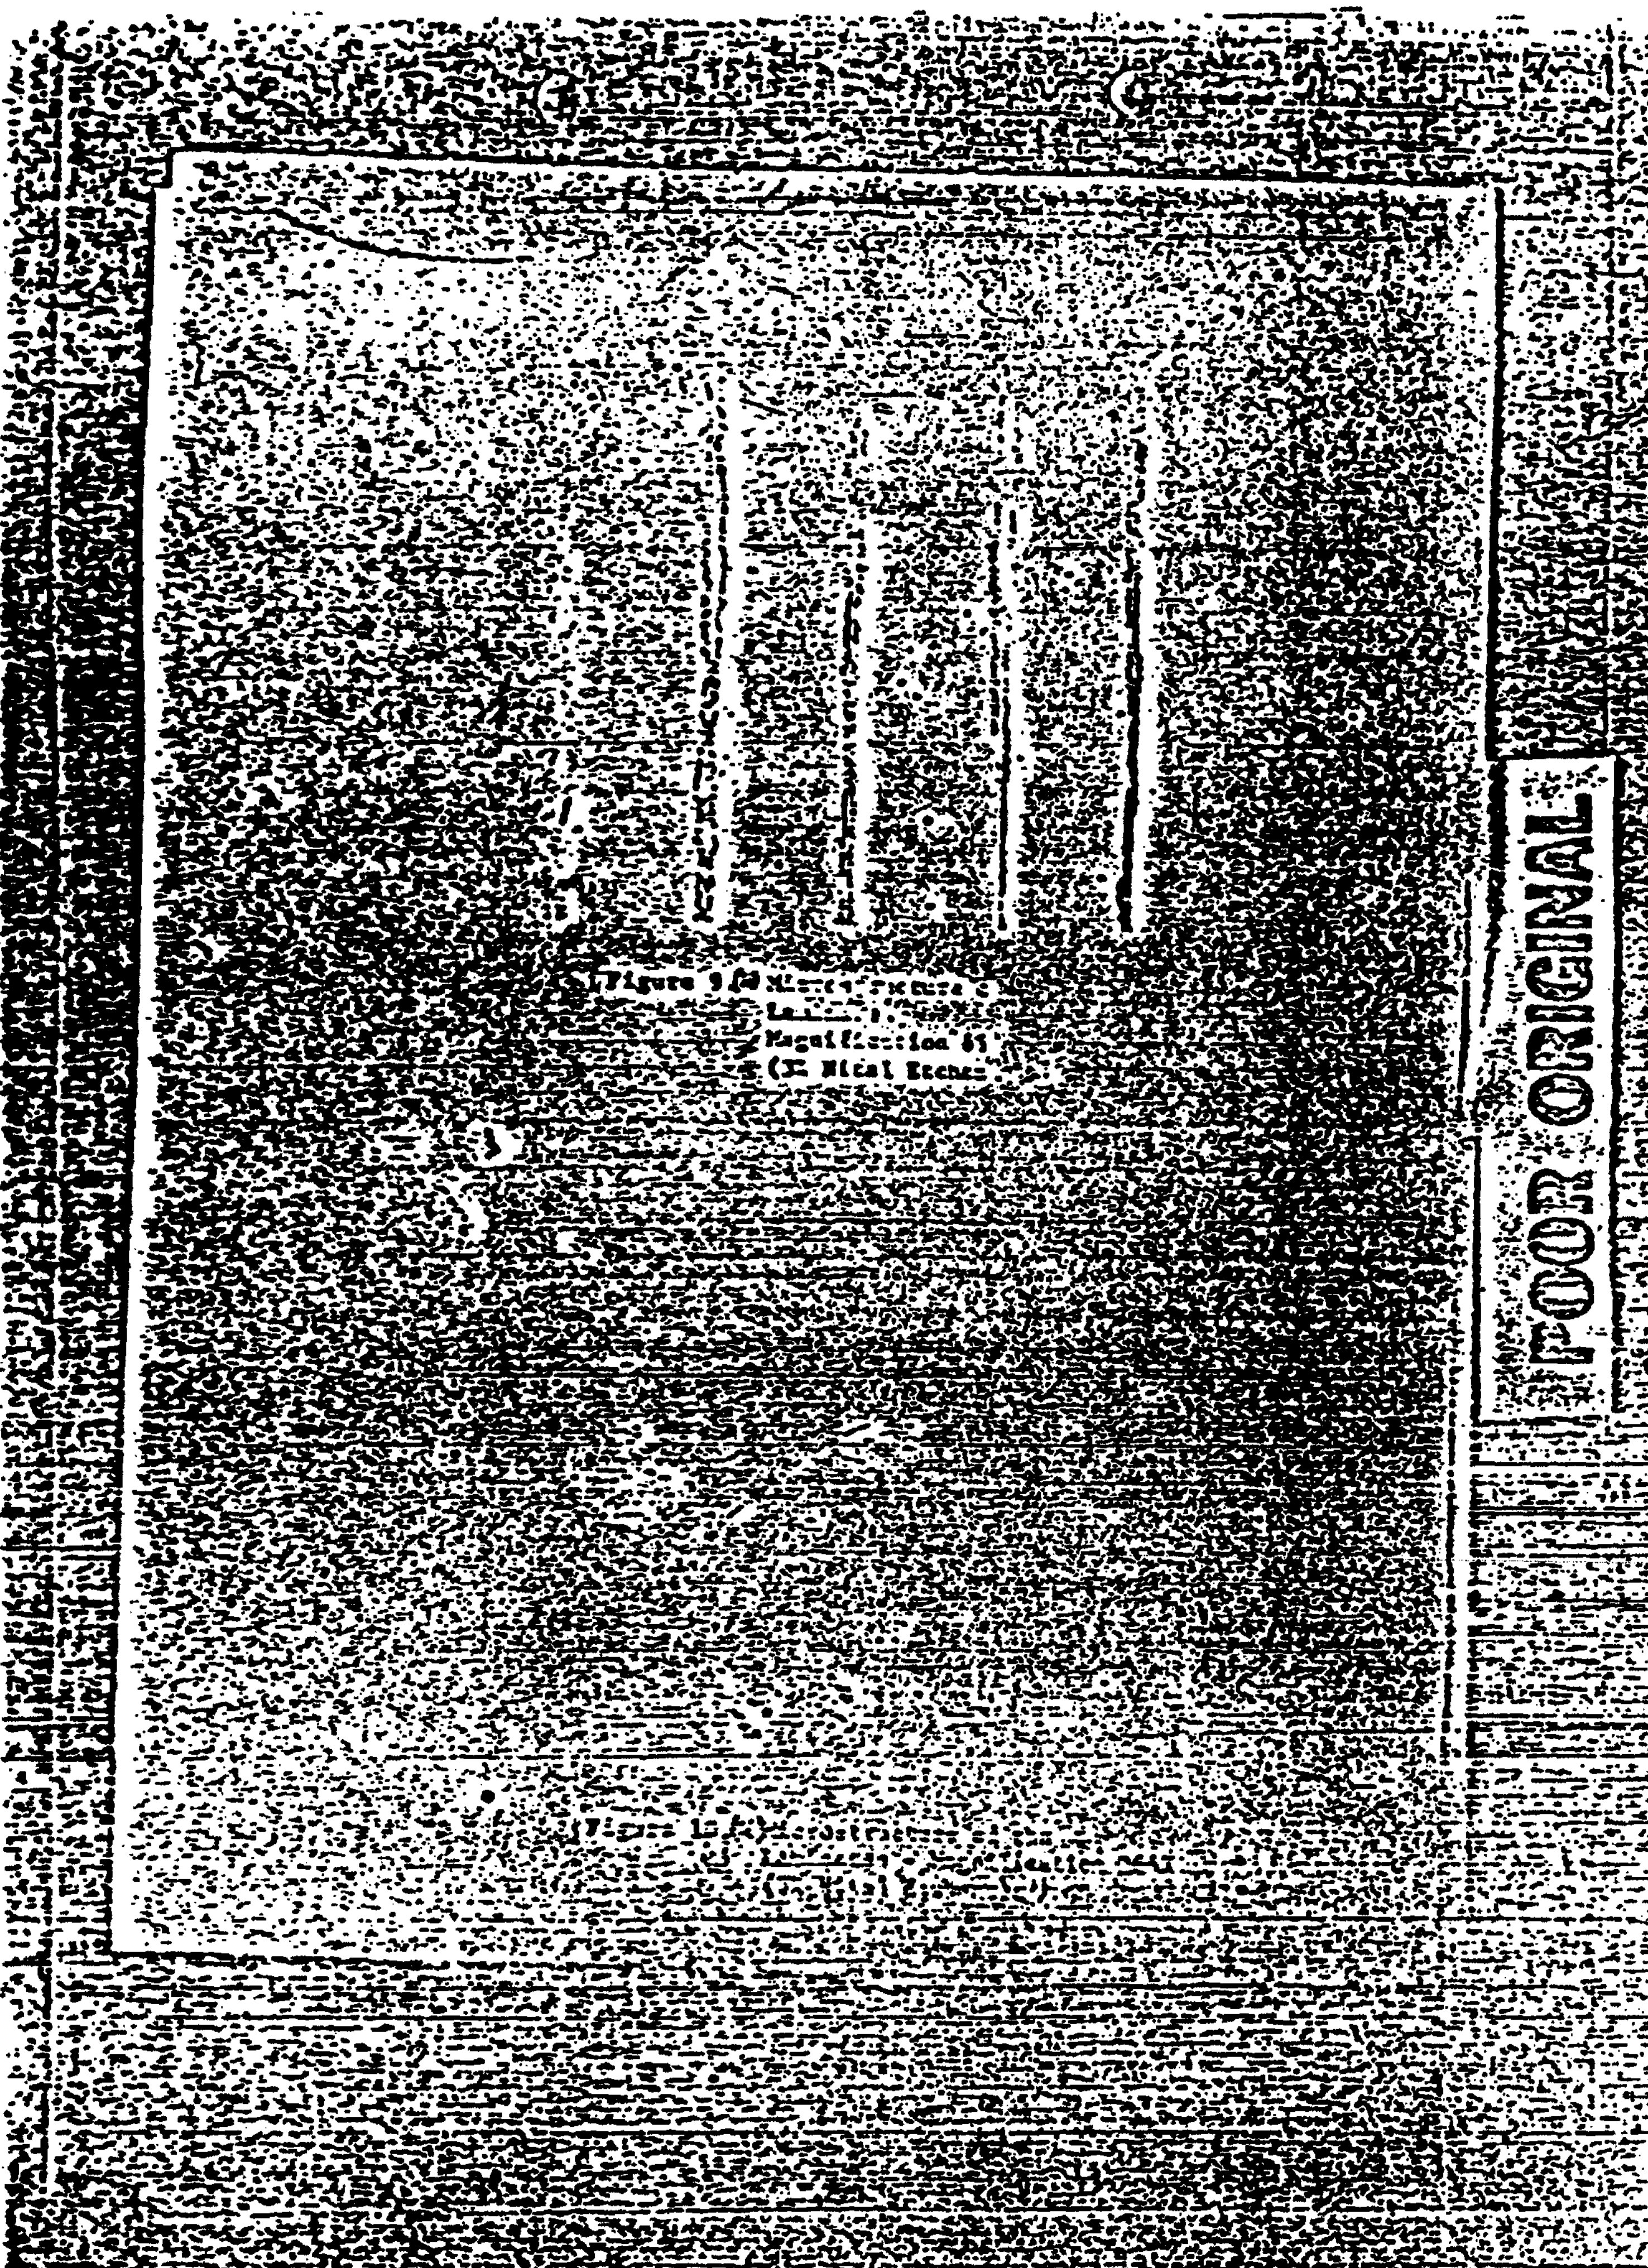
Figure 9 (a) [illegible]
Magnification [illegible]
([illegible] Nital Etchant)

11. (C) Another result of intense heating was the enlarged grain size of the steel laminates' microstructure. The microstructure of the laminates shown in Figures 9 and 10 illustrates grain sizes that are comparable to Category 2 of ASTM [illegible]. Large grain size [illegible]

12. (C) The light material between the laminations in Figure 9 is plated copper that melted and flowed between the laminations when the entire specimen was hot. A photomicrograph of this is shown in Figure 11.
