# Final report on potential breaches of biosecurity at the Pirbright site 2007

# Statement of key conclusions and recommendations

# Background

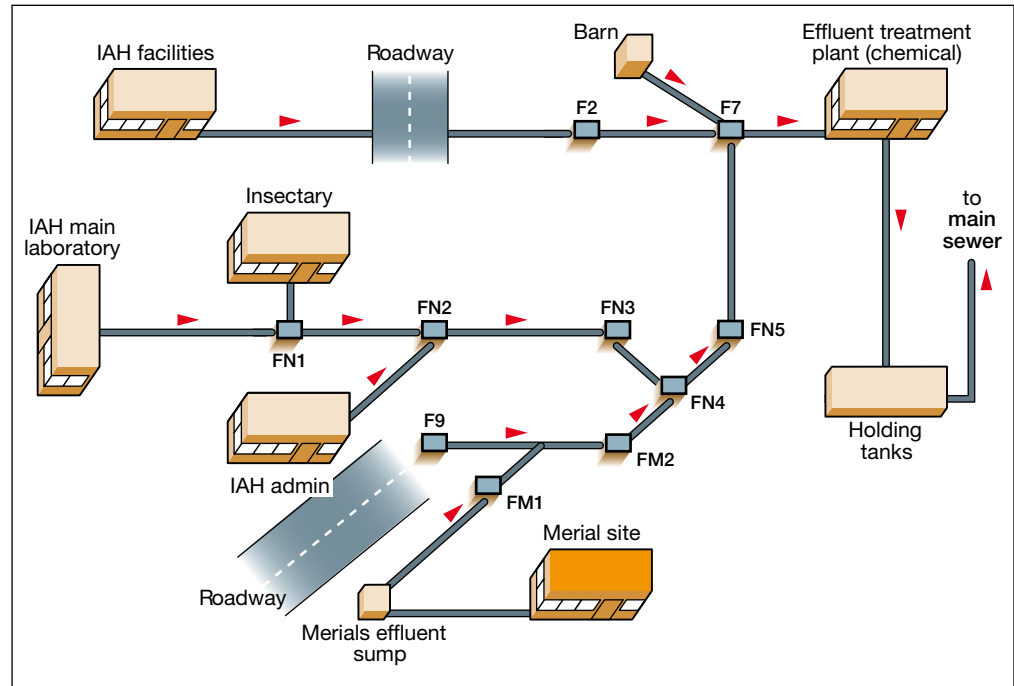
**Figure 3** A schematic of the site's effluent drainage system

tanks to be held for 24 hours. The pH in these tanks is recorded and the contents are discharged to the sewer at around pH 12. This sometimes requires the addition of extra caustic soda directly to the tanks. We inspected the logs of the discharges made during the period covered by our investigation and found no evidence that these were not as required. We have no reason to suspect that the final discharges to sewer were not as required. Once discharged, the waste is further treated at the nearby Hockford sewage treatment works. Key features of the site's effluent drainage system are shown in Figures 3 and 4.

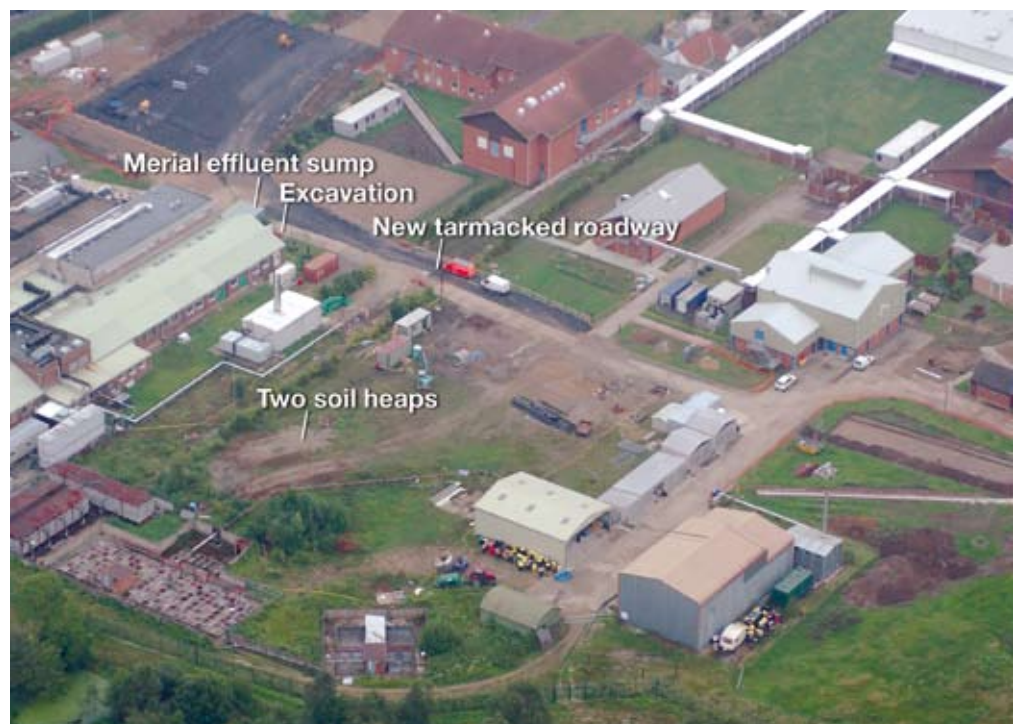
**Figure 6** Key contractor activities around the effluent drainage system  
(Photo courtesy of Surrey police)

221 Throughout the period under investigation, work was undertaken to remove soil and subsoil from the new roadway and lay a new surface. Some of the material was removed from site to a number of locations in the local area. Other material was used elsewhere on site. The roadway was widened in the area around Merial's effluent sump, passed close to where the excavation shown in Figure 5 was located and crossed the effluent drains leading from the IAH facility. This is shown in Figure 6. On 20 July work on the roadway was affected by the heavy rainfall: a small trench was dug at this time to try and divert water away from the portacabin facility used by the contractors in the vicinity of the road.

222 We identified that although some arrangements had been made for IAH to accompany construction workers at certain times and instructions had been given on the method of retaining potentially contaminated soil in a quarantine area at the site, these were not documented. In addition, the photograph of the spoil heaps in Figure 6 shows vehicle tracks over spoil indicating that access to this area was not restricted. There was no evidence of wheel washes or basic cleaning of vehicles involved in these activities.

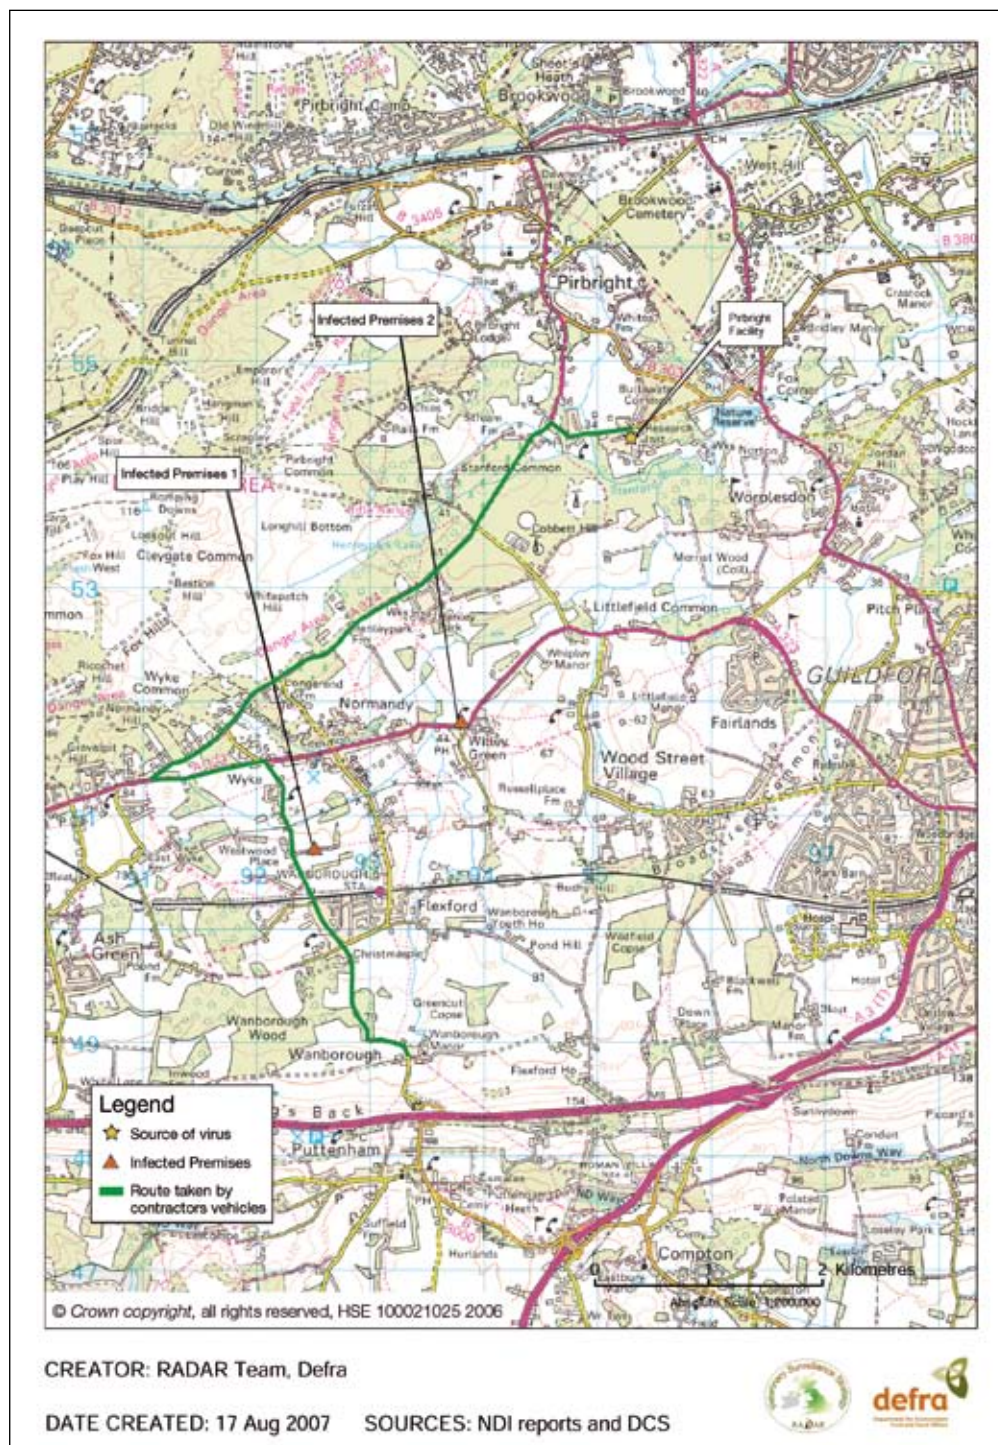
Figure 7 OS map showing route passed IP1

236 We identified that the route taken to Compton from the Pirbright site included Westwood Lane in Normandy, close to the first affected farm and known to be used by the farmer and visitors. This route is shown in Figure 7.

242 We believe that the movement of material contaminated with live FMDV virus O1 BFS along Westwood Lane provides a credible link between the Pirbright site and the first affected farm.

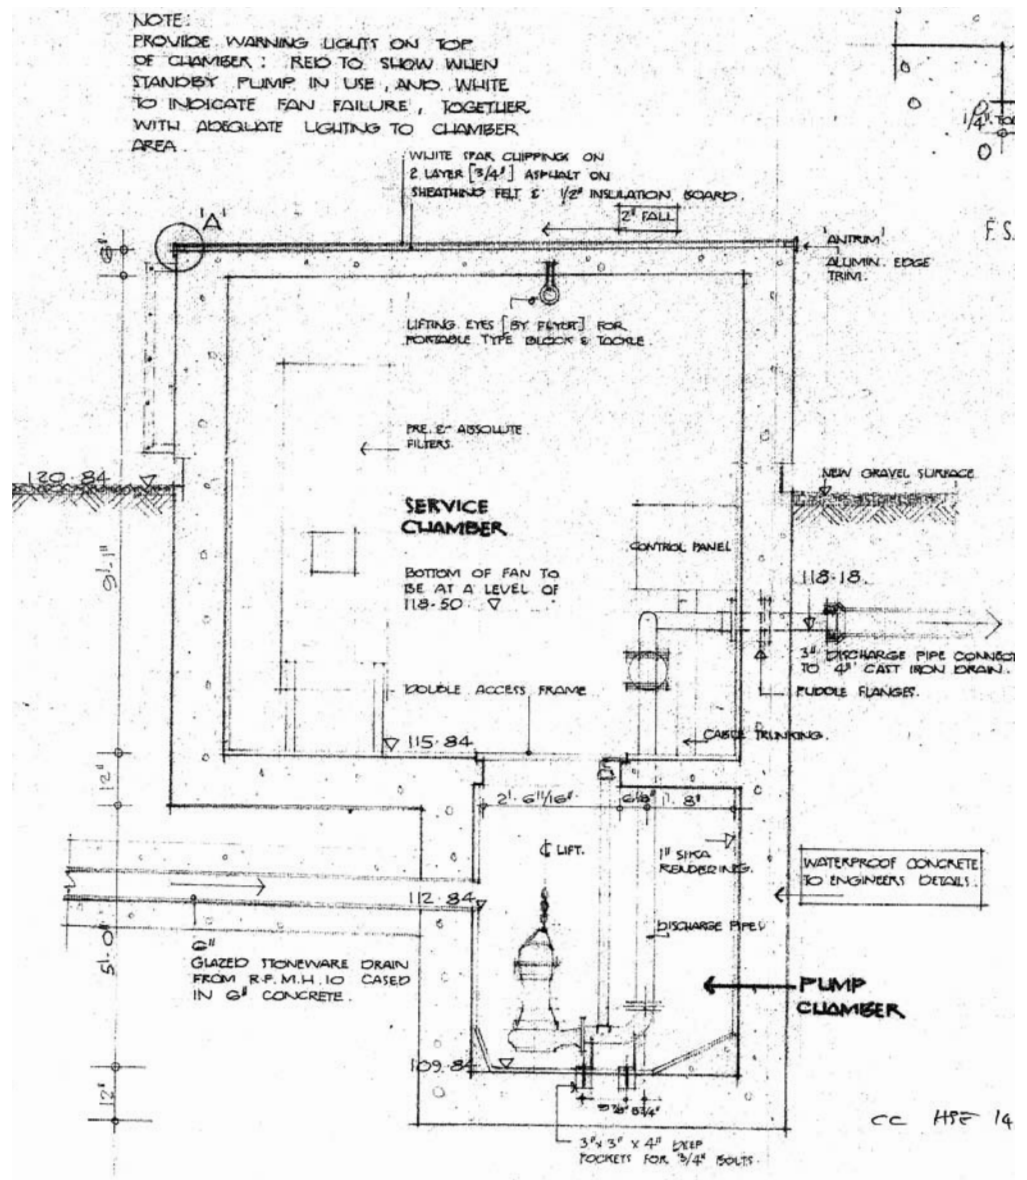
Figure 9 Section through Merial drainage sump

The effluent sump was constructed in about 1971, and is a reinforced concrete sump arrangement with an invert level of around 3.5 m below ground level. Figure 9 shows a section through the sump. The design standards for the sump are not known, and are not detailed on the available drawings. It should be noted that the lower sump level was coated with a 1-inch Sika plaster lining with the intention of providing an additional barrier to water egress. The inlet line into the sump is a 6-inch diameter salt-glazed clay line with a 6-inch concrete surround. The details of the various connections into the inlet line have not been reviewed. They originate beneath the production buildings and at the time of inspection were in use discharging small volumes of condensate and foul drainage from showers and toilets.

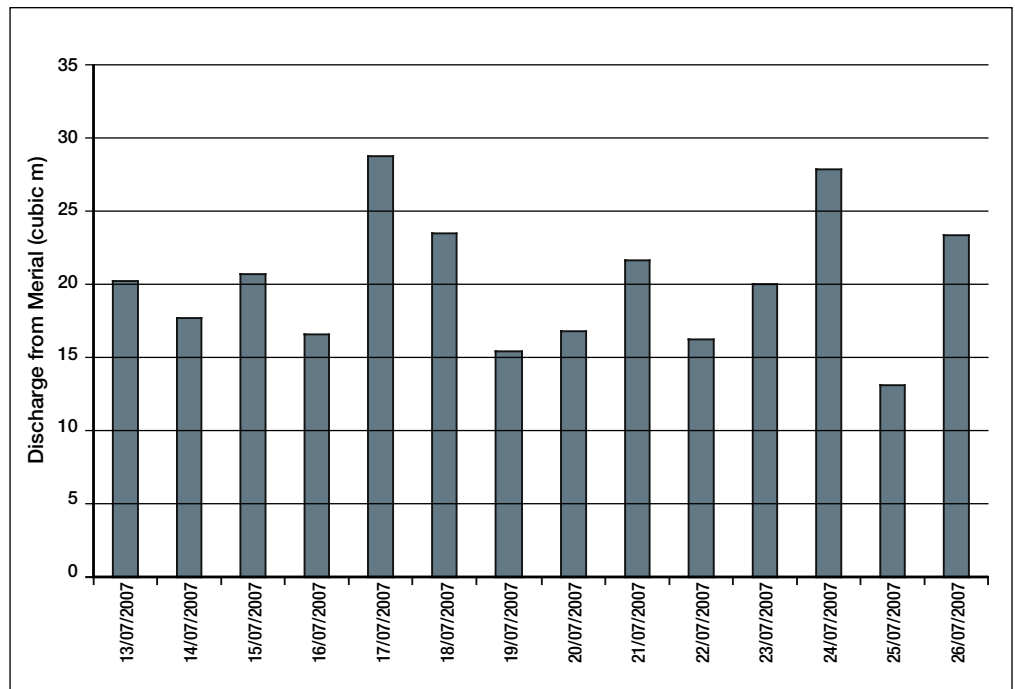
**Figure 10** Discharge volumes from the Merial sump

The level of effluent in the sump is monitored by a series of float switches, which control, through a simple logic circuit, the operation of the discharge pumps. Under normal circumstances, a single pump with a duty of 25 000 litres/hour is used, however, if the level continues to rise, a second (identical) pump is started. Under normal circumstances, the pump(s) will run for a few minutes at a time. During a normal production day, an average of 20 m<sup>3</sup> per day is discharged. This is monitored for charging purposes. Figure 10 shows the discharge history from mid-late July.

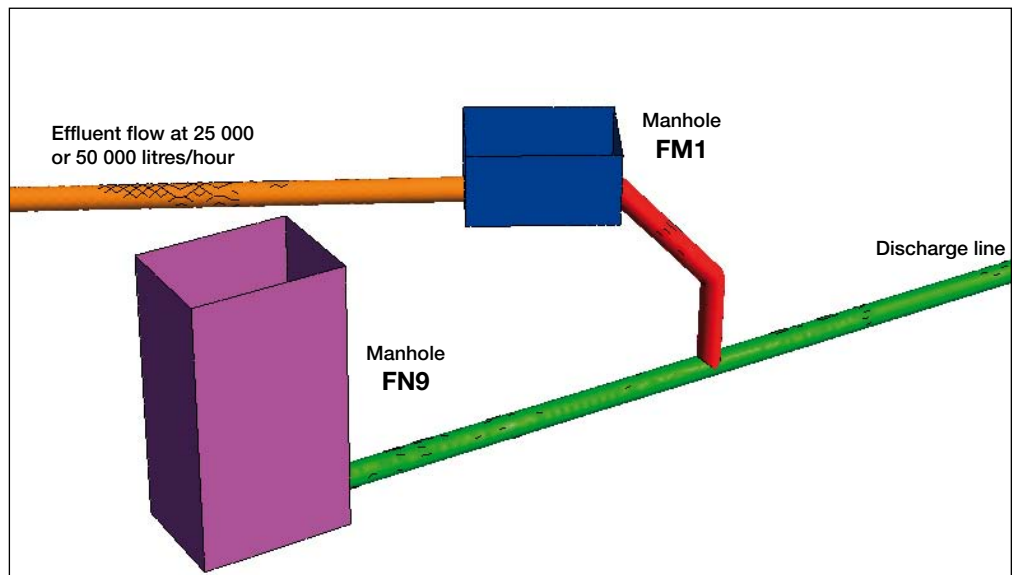
**Figure 11** CFD model of Merial discharge line connection to manhole FM1 and downstream connection

The discharge line is a 4-inch cast iron pipe, which has a 6-inch concrete surround. This has been exposed as part of an excavation immediately adjacent to the effluent sump (see Figure 13). This line has not been internally inspected by CCTV. The line rises in elevation from the sump up to manhole FM1 (see Figure 14). A short length of pipe (about 1.1 m) then taps into the IAH drainage run from FN9 to FM2. This run takes an unusual path and drops almost vertically into the crown of the existing line (see Figure 11 and Figure 15).

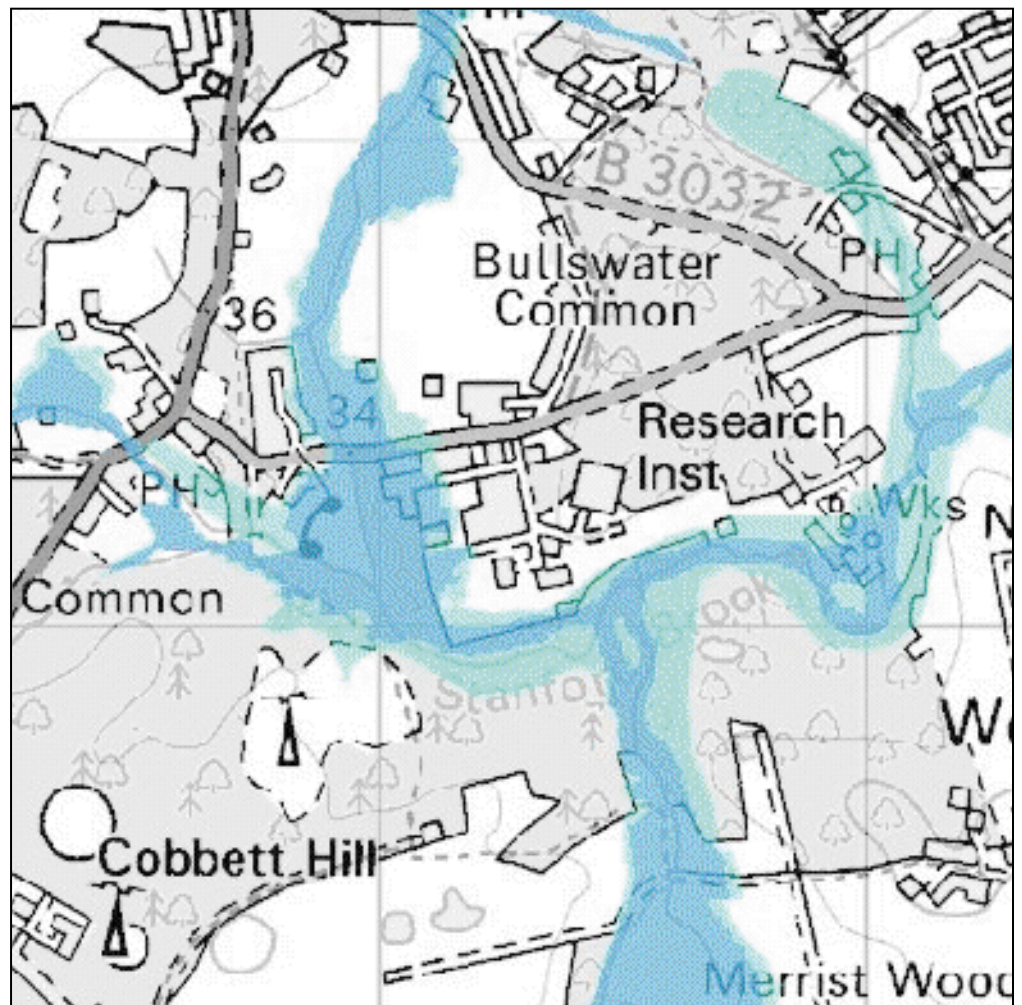
**Figure 12** Environment Agency flood map showing extreme levels of flood

The Environment Agency has undertaken some flood risk studies and has published them on their website. Figure 12 shows their predictions for flooding in an approximate 1 in 75 year event. This shows lower sections of the site potentially inundated as a result of the Stanford Brook levels rising, however, the inundation is limited in inactive areas of the site.
