# The Hat Trusses

## The Structural System of the Twin Towers

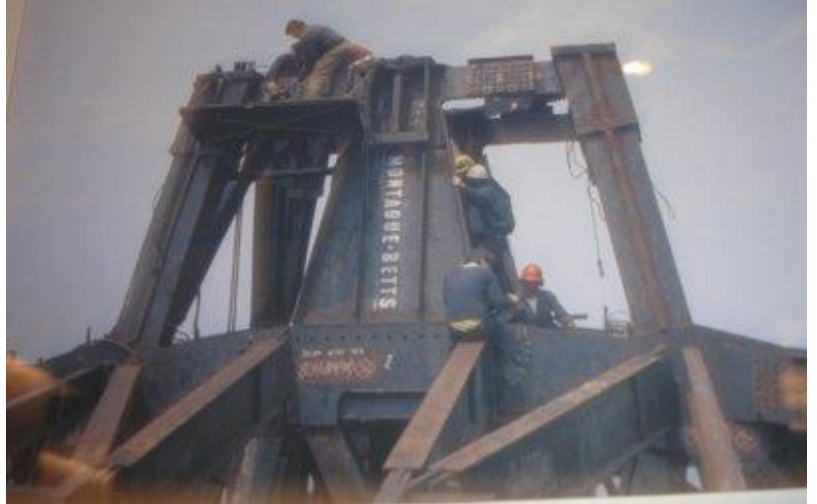
This photograph shows the top of the hat truss of one of the towers during its construction. credit: the [Skyscraper Museum](#)
